## Streambank Erosion Mapping on the Nottoway River Using GPS-based Above-water Video

Advisor: Dr. Paul Ayers

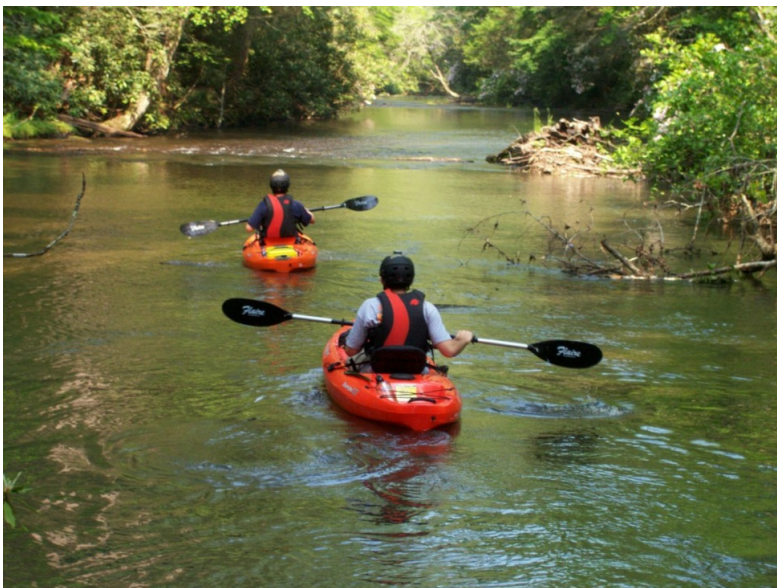
Figure 1  
*Instrumented kayaks floating the river thalweg.*

Mobile DVR's were used to collect the georeferenced digital video images. River depth measurements were recorded utilizing the CruzPro flush-mounted depth sensor (CruzPro Ltd.). The float path was attempted through the main section of the river, otherwise identified as the thalweg (Figure 1).

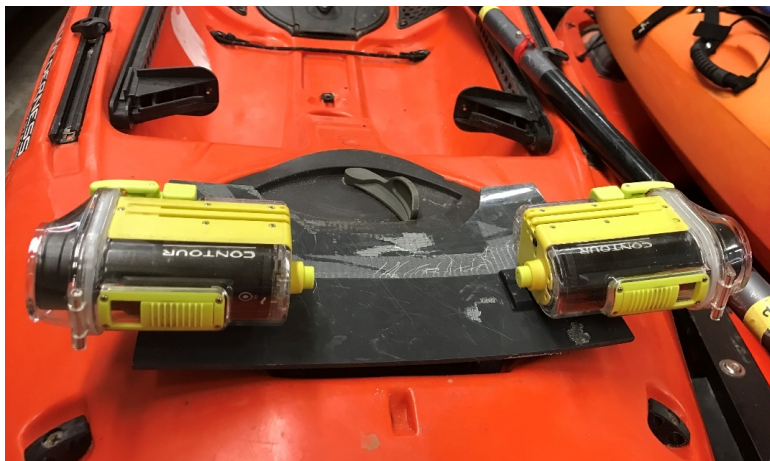
Figure 2

*Above water Contour cameras that were mounted to the bow of the kayak and pointed towards the left and right banks.*

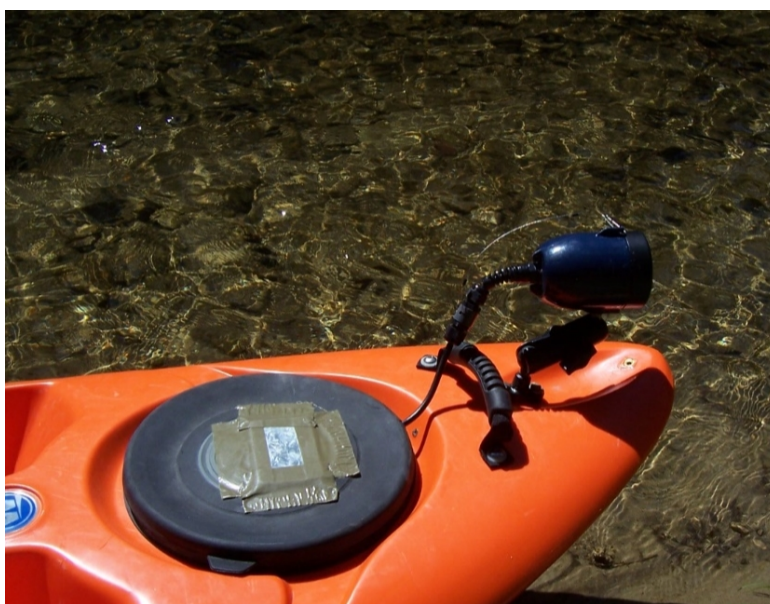
Figure 3

*Above water camera on the bow of the kayak and pointed directly toward the front to capture video data of river characteristics.*

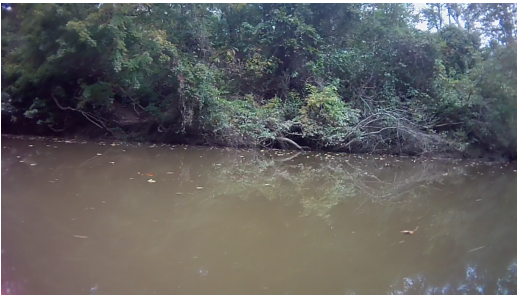
| Streambank Erosion Characteristics of the River | | |
|---|---|---|
| Low | The streambank is characterized with a growth of vegetation, small bank angle, and short bank height. | |

Figure 4  
Streambank erosion characteristics.

The georeferenced attributes of the streambank were manually classified by reviewing the digital images and field notes. GIS river streambank erosion maps were developed in ArcGIS 10.1. Aerial photography integrated within ArcGIS was utilized as background maps. Above-water video was viewed to define the river’s streambank erosion (low, medium, high) based on the Streambank erosion characteristics (Figure 4).

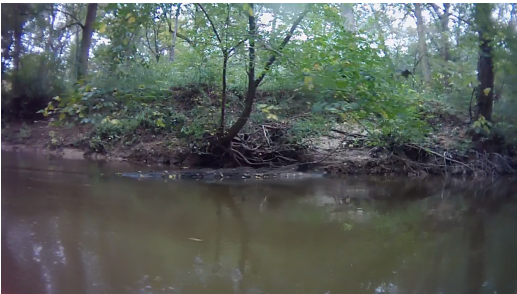
| Streambank Erosion Characteristics of the River | | |
|---|---|---|
| Medium | The bank contains little vegetation, slightly elevated bank angle, and/or a raised bank height. | |

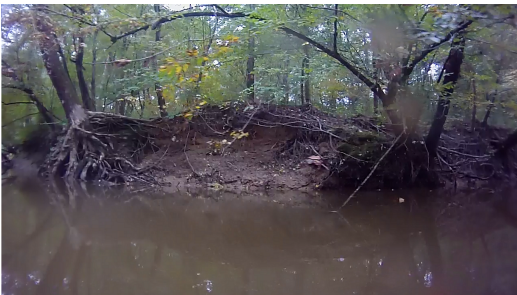
| Streambank Erosion Characteristics of the River | | |
|---|---|---|
| High | The area is characterized with no vegetation, large bank angle, and elevated bank height. | |
